# KIS Nose-Wheel Assembly

Taken from KIS4 – N819PR (4/24/2013)

Complete Nose Wheel Assembly

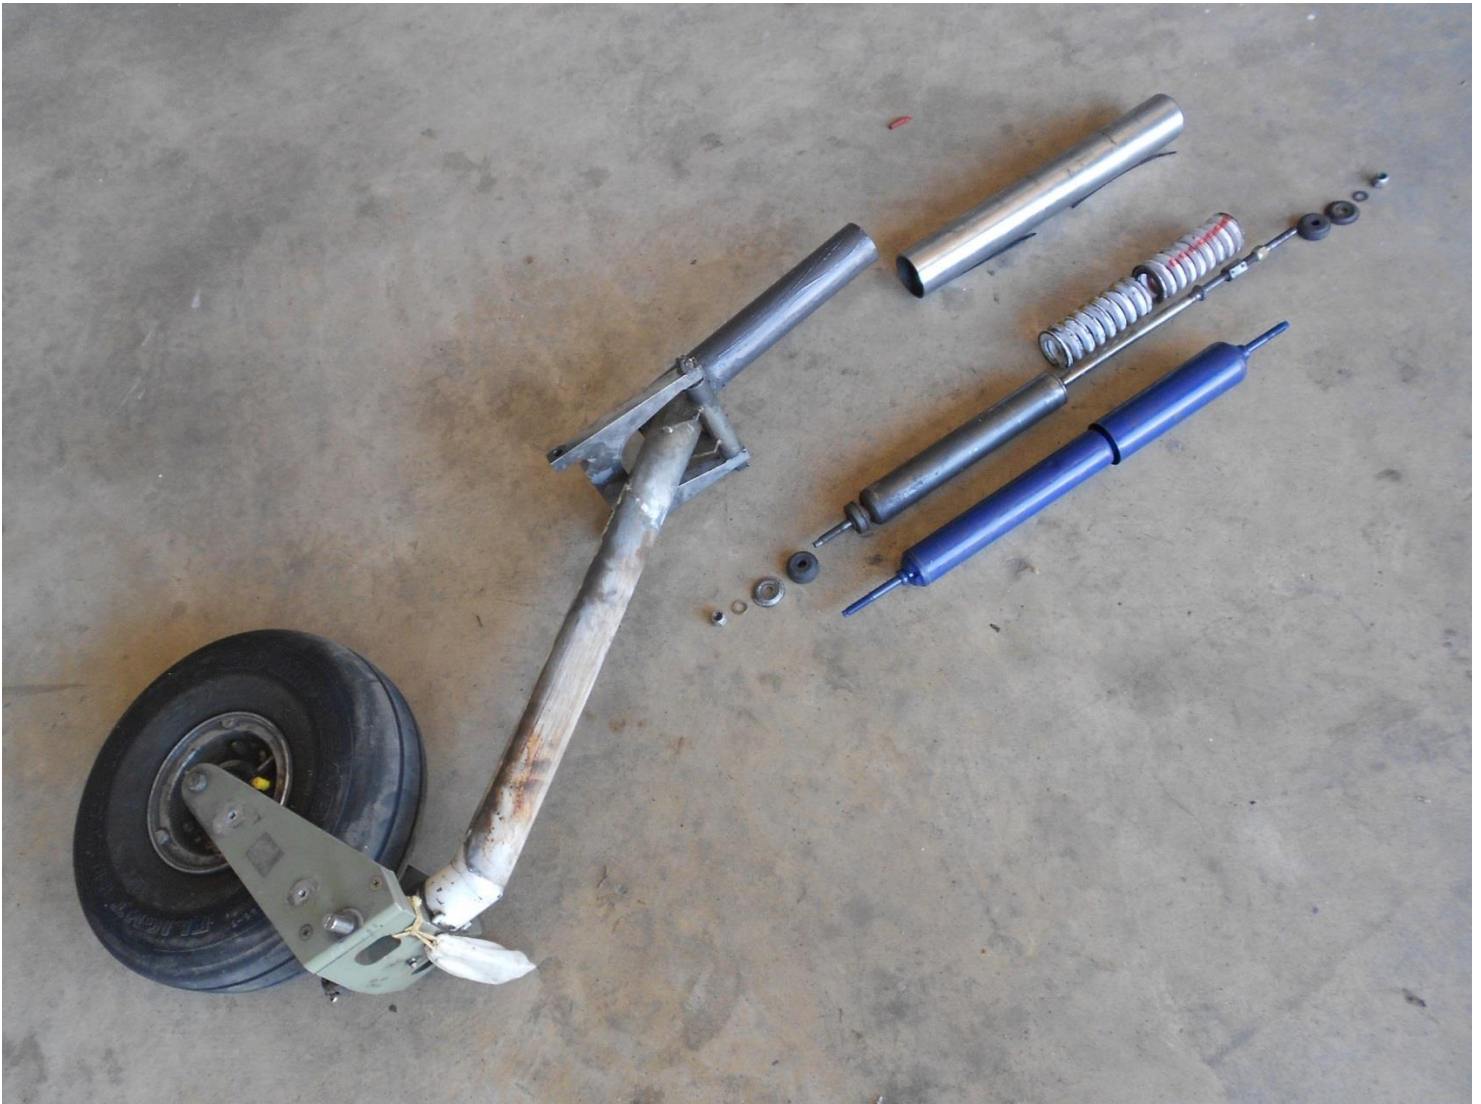
## Disassembled Nose Wheel Assembly

How the parts go together inside the nose-wheel assembly. The bright “chrome” part is the top of the assembly.

The top of the old shock absorber has the “dust cover” cut off and a 3/8” dia. lengthening adaptor threaded rod is affixed to it. The shock absorber measures a total of 25” long from the top of the lengthening adaptor threaded rod to the bottom of the shock absorber threaded rod. Two 4-1/2” steel springs are inserted as spacers where the dust cover would have been. NOTE: The blue new replacement shock absorber (Monroe-Matic Plus 31069) does NOT have its dust cover removed in the picture.

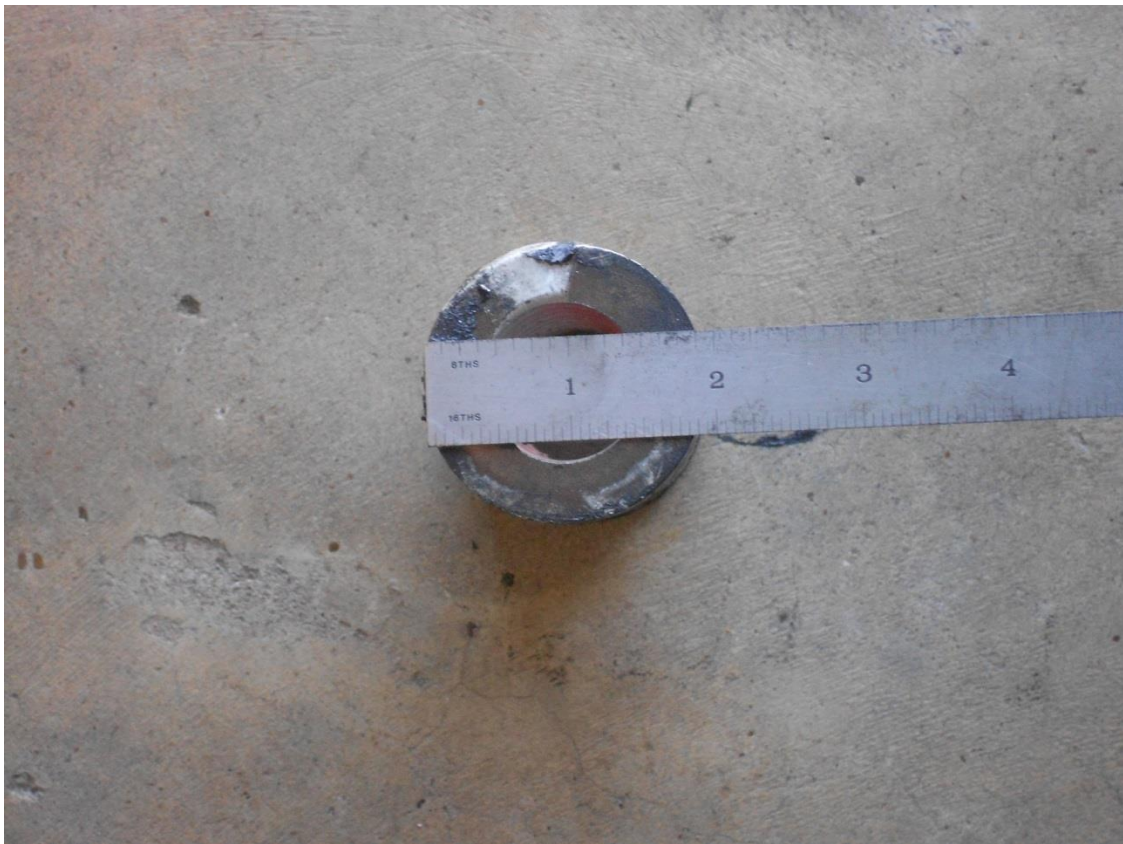
## Steel Springs Measurements

Each steel spring is 4-½" long and 1-15/16" in diameter made of 5/16" thick steel.

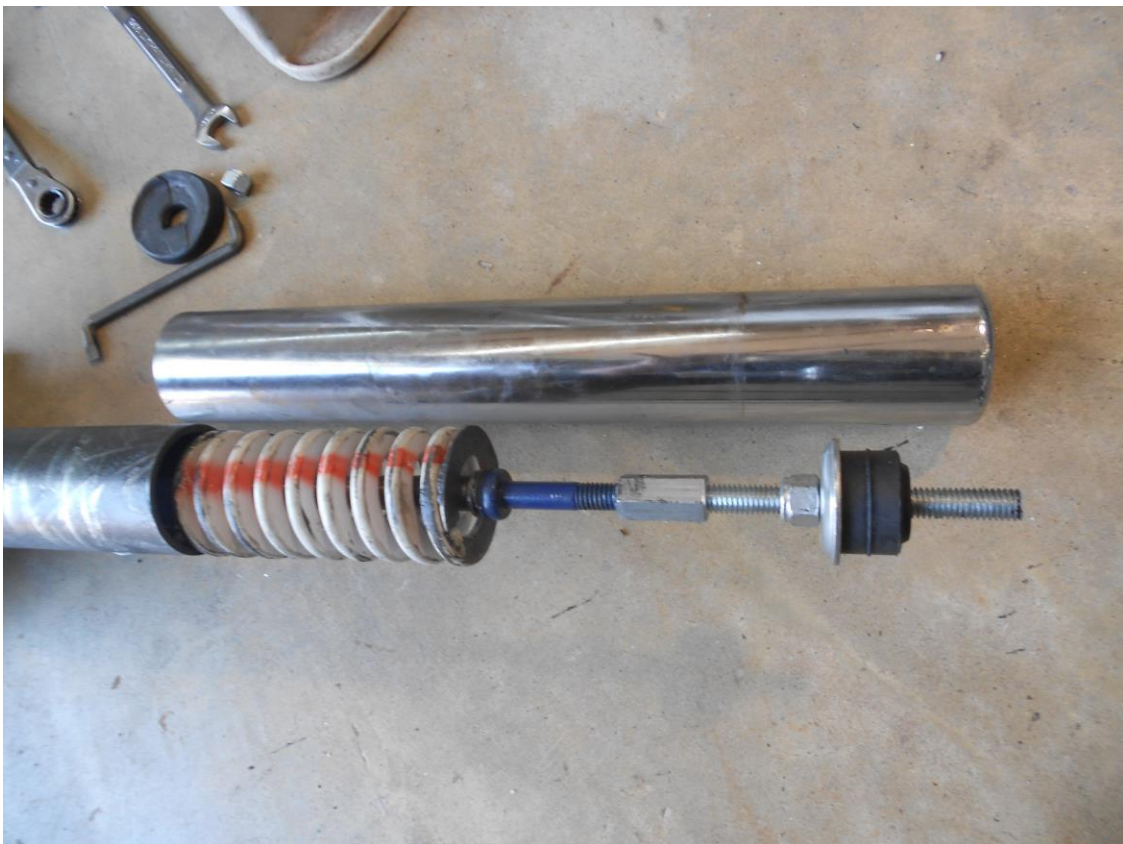
The 3/8" dia. lengthening adaptor threaded rod is shown in detail in the previous photos. The nut provides a stop to help prevent it being over tightened during installation. A rubber grommet is placed there to prevent a metal to metal connection which winds up inside the assembly.

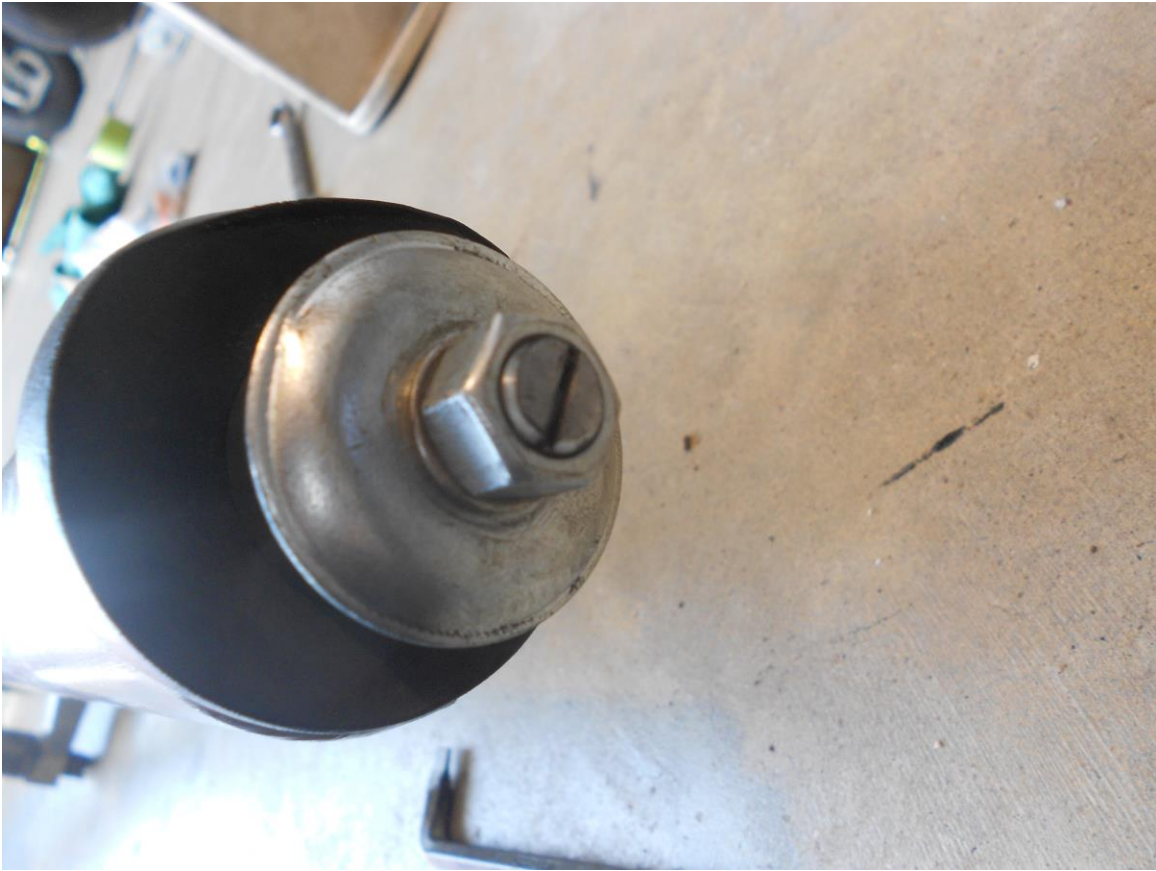
The top of the threaded rod extender needs to have a screwdriver slot cut in to it in order to adjust it during installation.

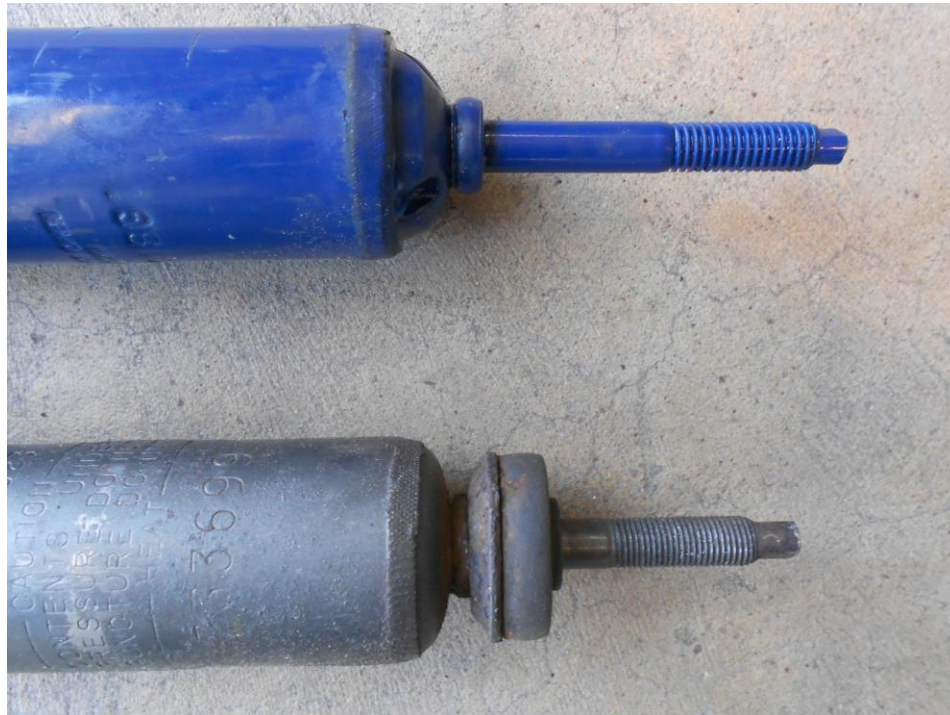
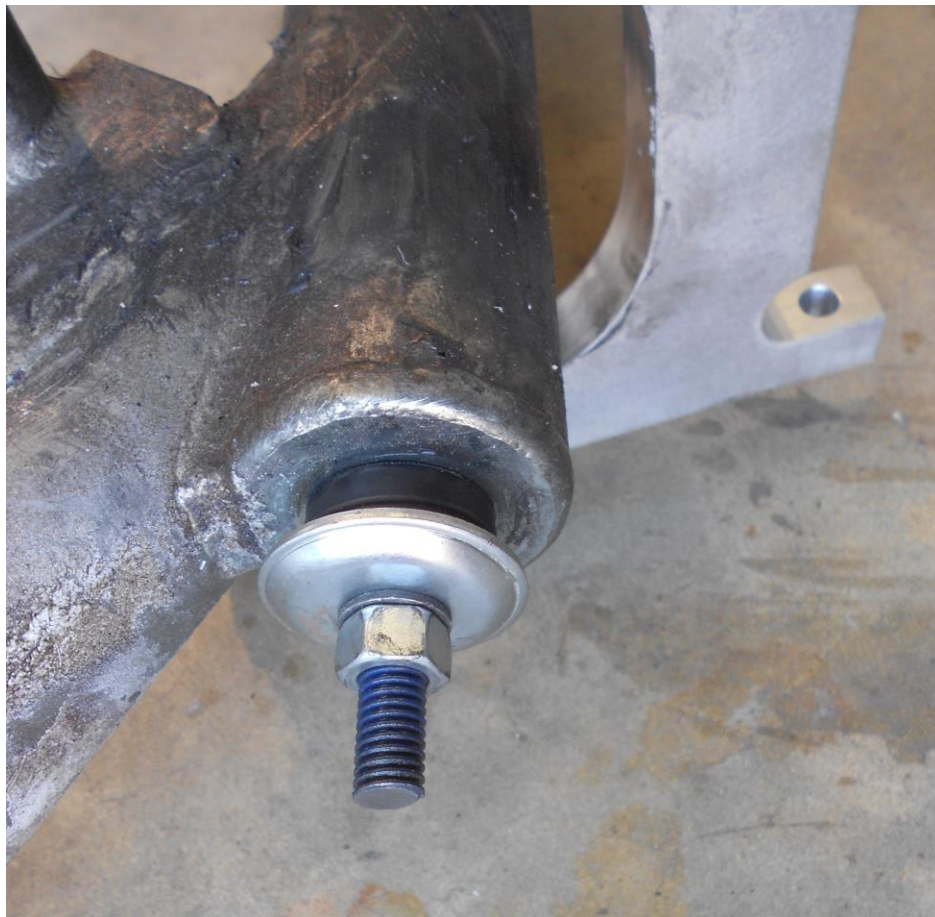
## Bottom of the Shock Absorber (Monroe-Matic Plus 31069)

There is a rubber grommet on the bottom of the shock absorber inside the assembly and on the bottom of the entire assembly as seen in the above photos.

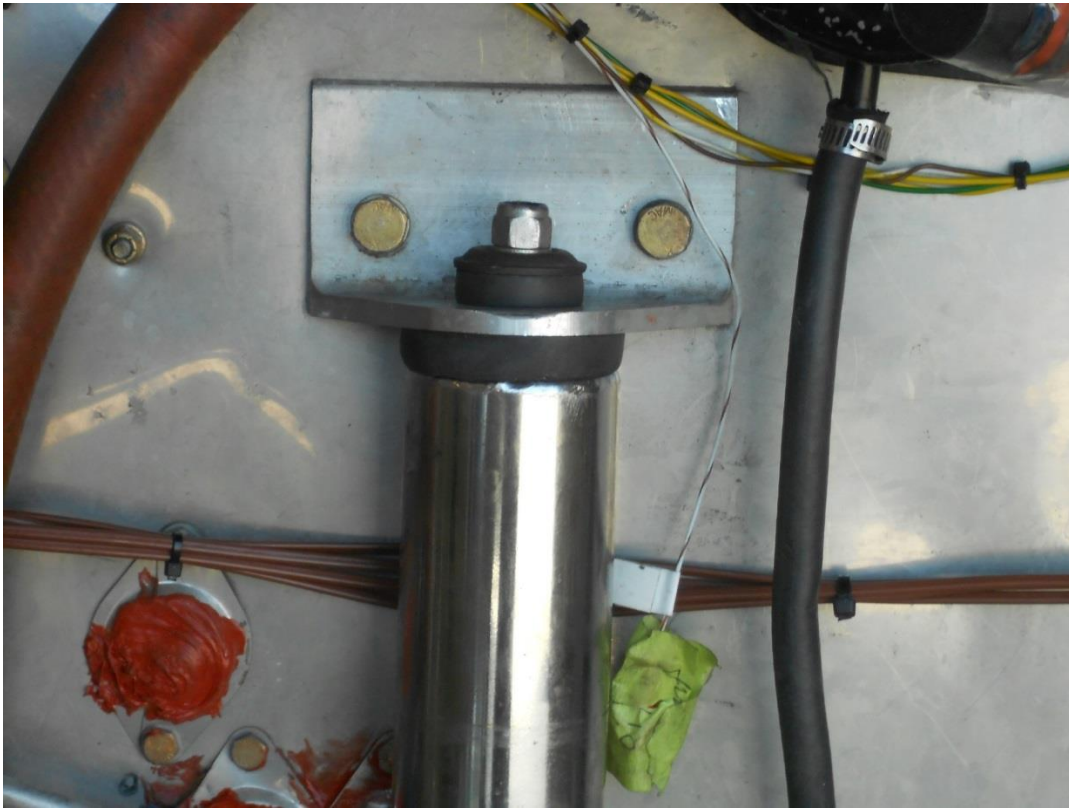
## Shock Absorber inside the assembly.

There is a thick piece of rubber or polyurethane between the outside top of the assembly and the firewall mounting bracket, as seen in the above photo, to help diminish forward/rear torque forces during landings. There is a rubber grommet on top of the firewall mounting bracket. I installed a hard plastic bushing inside the aluminum mounting bracket to prevent the lengthening adaptor threaded rod from cutting in to the bracket during landings.

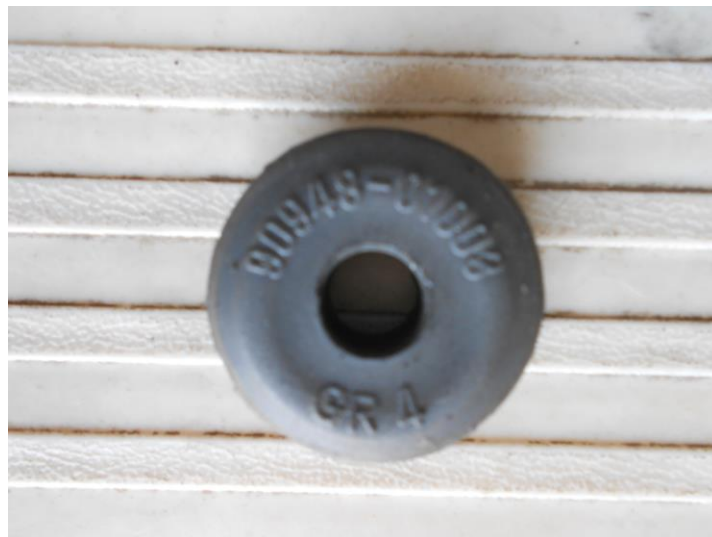
The rubber grommets supplied with the replacement shock absorber were too thick for my particular installation. I would up using a thinner ones (90948-01008) inside the assembly as seen in the above photo.
